Smallstock RFID

Trial of New Lamb Gambrel RFID hooks at JBS
Bordertown

Project Code
2021-1206

Published by
AMPC

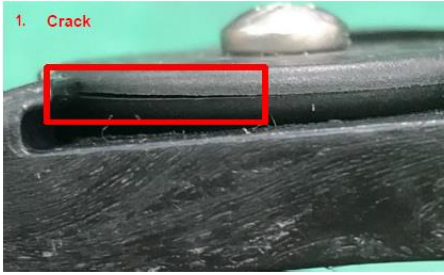
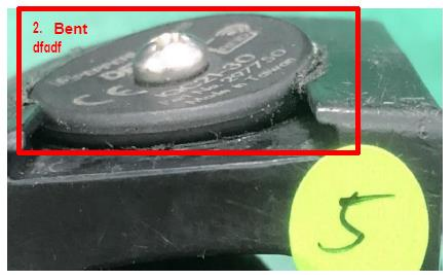
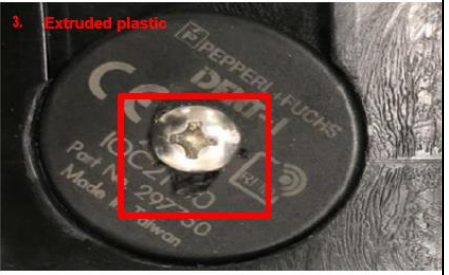
Visual Observations of Returned Tags

<p>Crack at the edge</p>	<p>The tag has been bent</p>	<p>Extruded plastic from the screw hole</p>

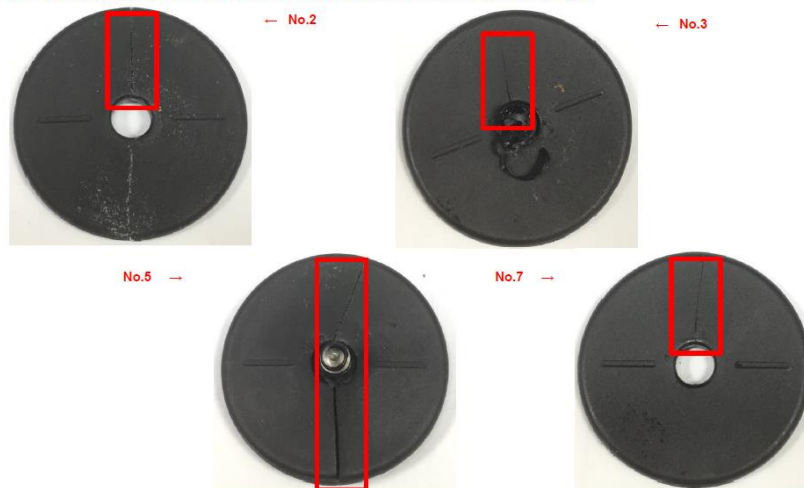
We disassembled the tag from the hook and found cracks on the tag

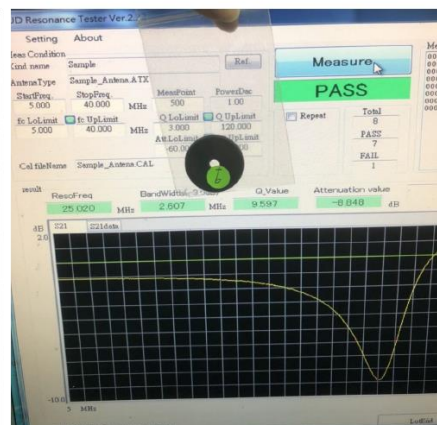
Reading ability of tag once removed from 10 gambrels

Only Tag No.2 is OK, others are NG (No Good)

No.	Frequency (13.56±0.5MHz)	Reader
2	13.6	OK
3	25.65	NG
4	25.72	NG
5	13.7	NG
6	27.47	NG
7	25.86	NG
8	25.58	NG
9	25.02	NG

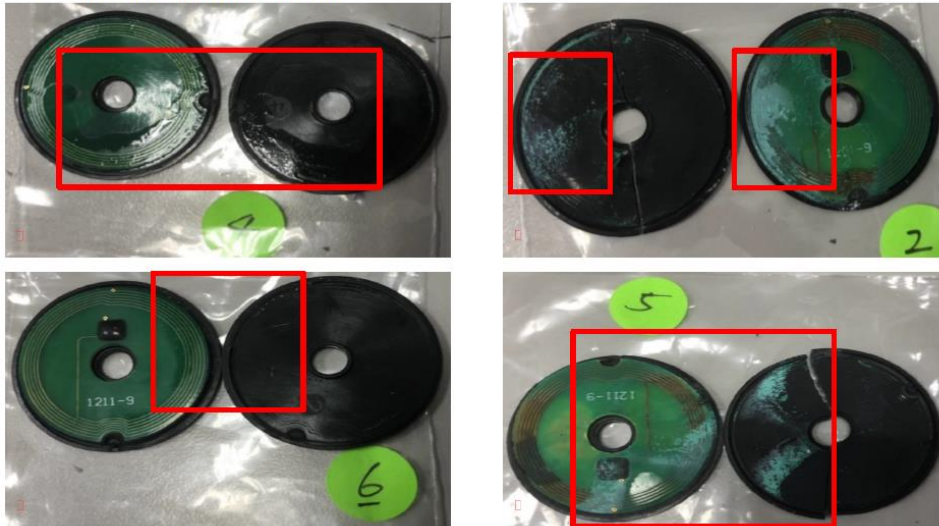
Removed RFID chips internal inspection

We disassembled the tags and found that there was liquid inside the e-unit.

1. Wet liquid
2. Dried and crystallized liquid

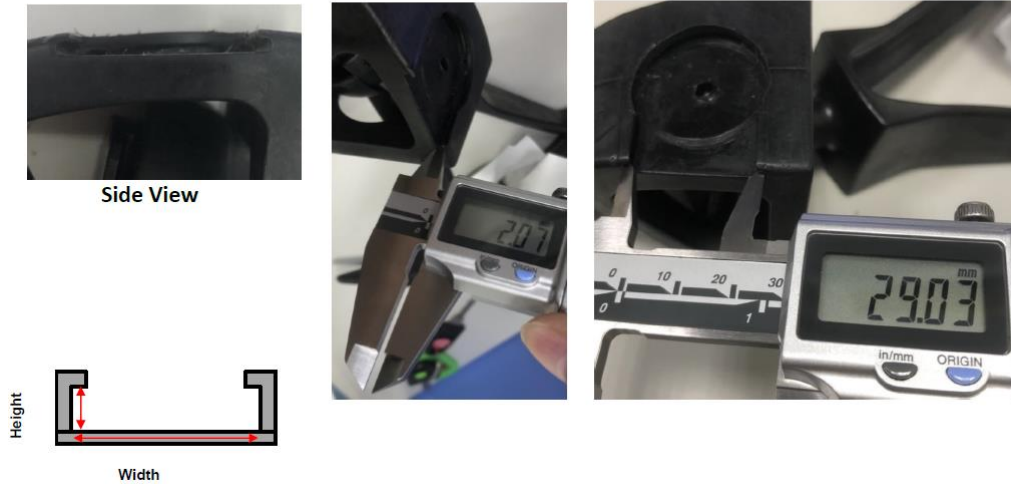
Removed RFID chips installation technique inspection (after the event)

1. The height of the track: 2.07mm
2. The width of the cavity: 29.03mm

Apparently, the cavity and the track are smaller than the tag, so the tag cannot be slid into the track successfully, neither be fitted into the cavity appropriately.

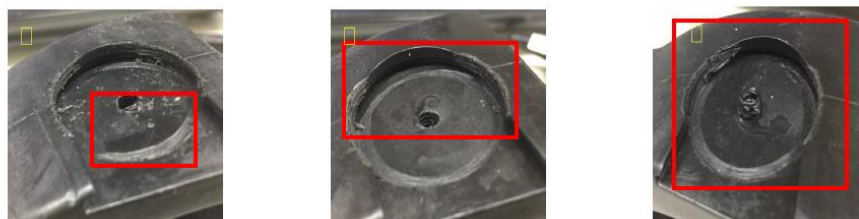
According to the picture shown below, there was damage on the edge of the cavity which we assume was caused by excessive force in order to press the tag into the cavity.

According to the tests we have done, we confirmed that the root cause of NG (No Good) tags was excessive force to press the tags down into a smaller cavity on the hook and other possible impacts. So, the tags were damaged during the assembly process and further aggravated when got impacts during the falling into the chute process. The chemical solution has permeated into the tags from the cracks. Some of the PCB have deformed and destroyed. So, the e-units were damaged and lost function gradually after repeated chemical washing cycles.

1. Turn key third-party supply (gambrel and RFID chip) as a turnkey solution.
2. Purchasing new gambrels and RFID chips and retrofitting under now established work instructions at JBS Bordertown, with suitable tooling and staff skills.
3. Repurposing existing gambrels, remove old RFID chips, increasing tolerances, reinstalling new RFID chips.
