# Water reduced small stock evisceration table wash

Project Code  
2021 - 1112

Prepared by  
V&V Walsh

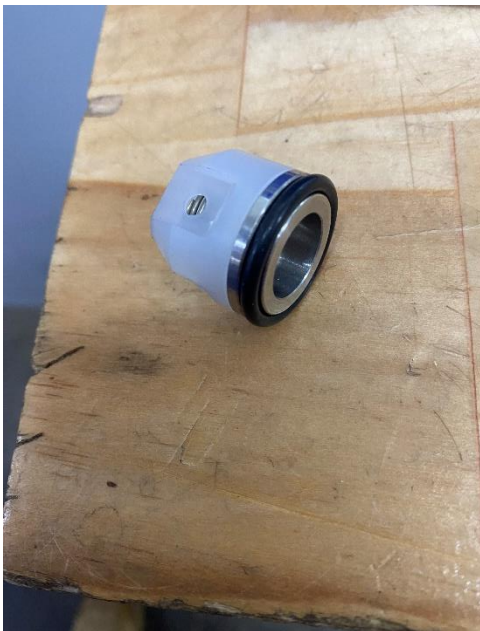
Image 1: Udor Teflon Cage Valve Replacement

The new Teflon Udor valve kit cages resulted in the OEM pumps output returning to a consistent operation. Since implantation of the Teflon pump cage kits, the OEM pump has had no further issues with loss of pressure, water infiltration into the oil cooler or overheating. As a direct result of this and leading into high production period, the decision was made to continue using the OEM pumping system over the Warble pump.

During the time of inconsistent operation of the Warble Plate Positive Displacement pump, the plant maintenance manager sourced Udor Teflon pump cage replacement parts for the OEM hot water pump as a trial while fault diagnosis was being performed on the Warble pump.

Water efficiency has been improved with the implementation of the Udon teflon cages. Previous flow was at times detected at 3L/min for the OEM hot water pump prior to Udon instillation and when other parts were faulting because of the water temperature. After several trails of replacements, the Udon cages proved to be the most reliable and reduced water usage to 2L/min during operation.

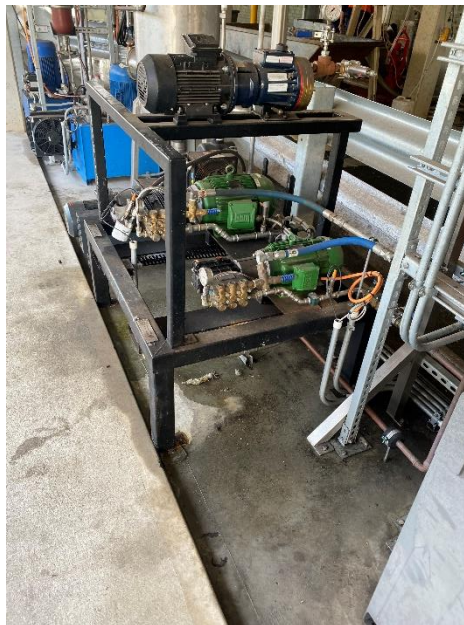
Image 2: OEM and Warble Pump Station

The Warble pump however has not gone unused. The discharge line was fitted with a spirex air trap to prevent build-up of steam within the discharge line. The Warble Plate Positive Displacement pump now serves as a redundancy for the system should further complications occur from the OEM pumping system.

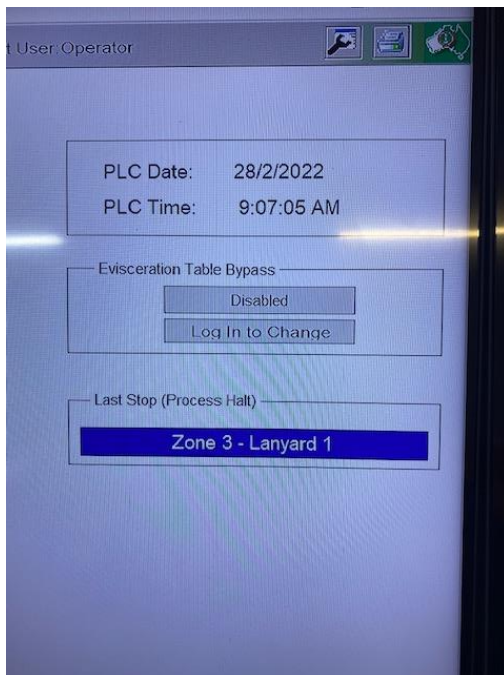
Image 3: SCADA Evisceration table europump bypass notification

- ◆ Process halts associated with the evisceration table specifically
  - E-Stop used to stop the evisceration table cleaning system (OEM/Warble pumps)
  - Counter to identify number of stops per day.
- ◆ Bypass notification of evisceration table
  - Notifications when the OEM system has been bypassed to allow the evisceration table to operate without the OEM system.
- ◆ Euro pump system run indication
  - Notifications when pumps are running to identify if pump is running outside of production or without flow
