Robot Implementation on the Casino Food Coop site

AGVs (with articulated legs) - Stage 2 & 3
Services

Project Code
2021-1271

Prepared by
Haydn Bradfield

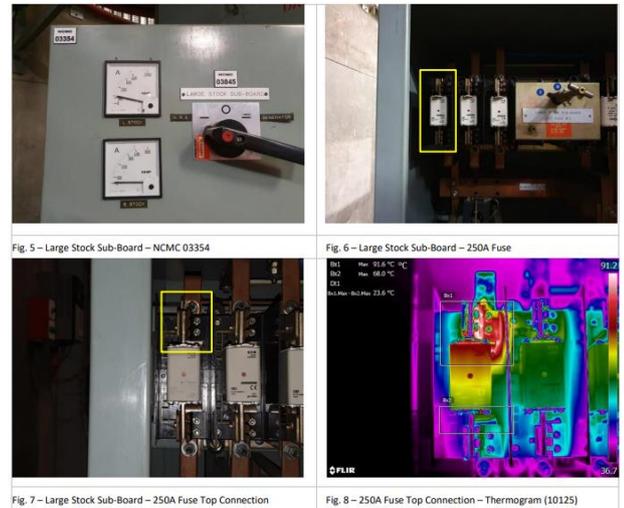
Perform Thermal inspections of electrical and mechanical equipment to detect anomalies and faults for preventative maintenance (as per the below image extracted from the 2021 February THERMOGRAPHIC INSPECTION REPORT) (Dravsnik, 2021)

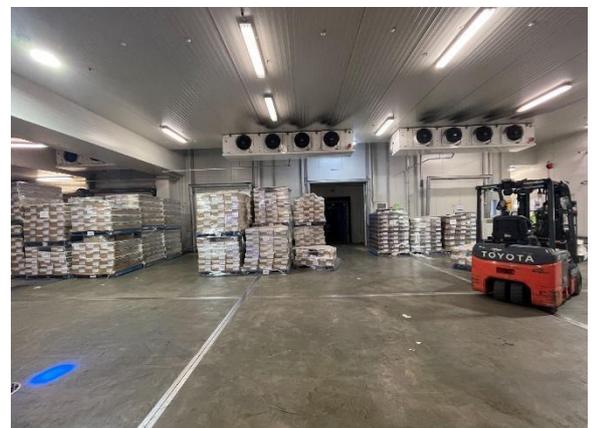
Figure 3 Casino Food Coop - Loading Area

When a receiving delivery truck backs into the loading bays they are opened, and a robot can autonomously navigate into the truck to capture a visual condition and record the inside of the truck. The robot then moves to the packed pallets, walks around the pallets, and uses a sensor or photography and vision systems to document all the barcodes of the items to be loaded.

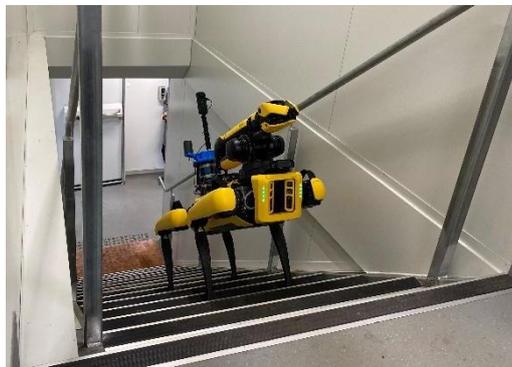
Spot was able to successfully navigate up and down staircases. There were some occasions where the robot mistook its surroundings or its footing resulting in a fall down the stairs. During one of these falls the only damage sustained to the robot was the breakage of a plastic 3rd party bracket that the project team had installed.

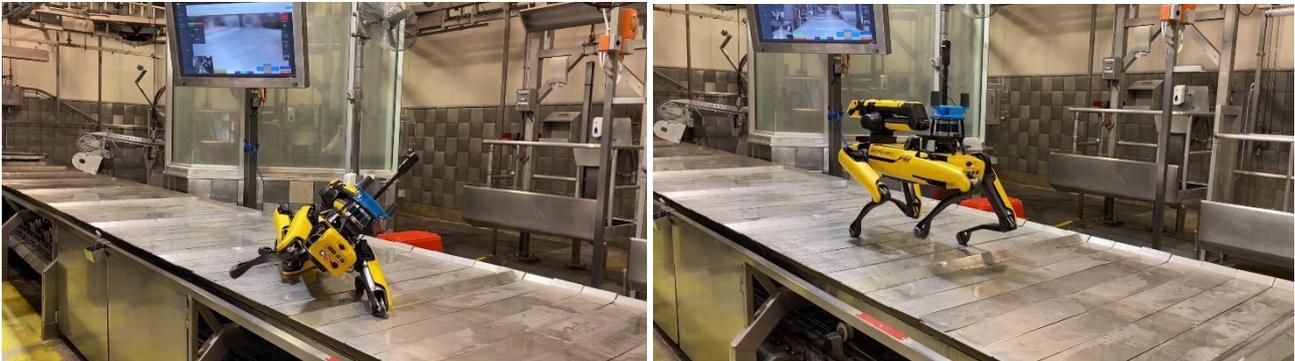
During a test on the evisceration table the robot happened to collapse on the initial test but succeeded on the follow-up attempt. The first collapse of the robot, upon review of the footage found in the *"General Robot Functions and Testing"* folder in the project media, is attributed to the slippery surface of the conveyor and not solely for the moving

nature of the surface. This functionality is considered incredibly difficult for a robot to complete as there are thousands of stability algorithms being used to compensate for the robot's movements with the assumption that the ground is stable and stationary. Having the robot on a moving platform incorporates a whole new element of a dynamic environment and the success of this test is a testament to the advanced capabilities of the Spot robot.

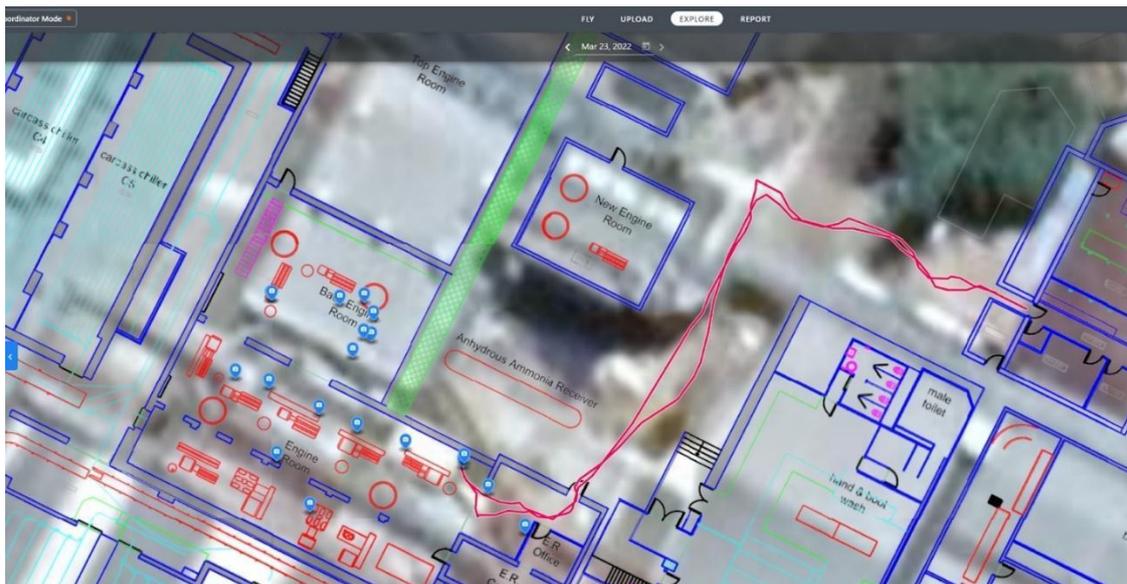
Figure 5 DroneDeploy's 360 Walkthroughs and Photos aligned to an aerial image with a Site overlay

In the images below you can see in the DroneDeploy platform the 360 walkthroughs are aligned (pink trajectory) to the facility layout drawings and the point and shoot inspection images (blue icons) are placed along the trajectory where they were taken, although in this case, the 360 walkthroughs failed to extend into the inspected area but the point and shoot missions were comprehensive in that area. The user can then teleport anywhere along the pink trajectory to get a compressive 360 view in that location. Further movement in that photo view is available by clicking the augmented arrows in the image along the path.

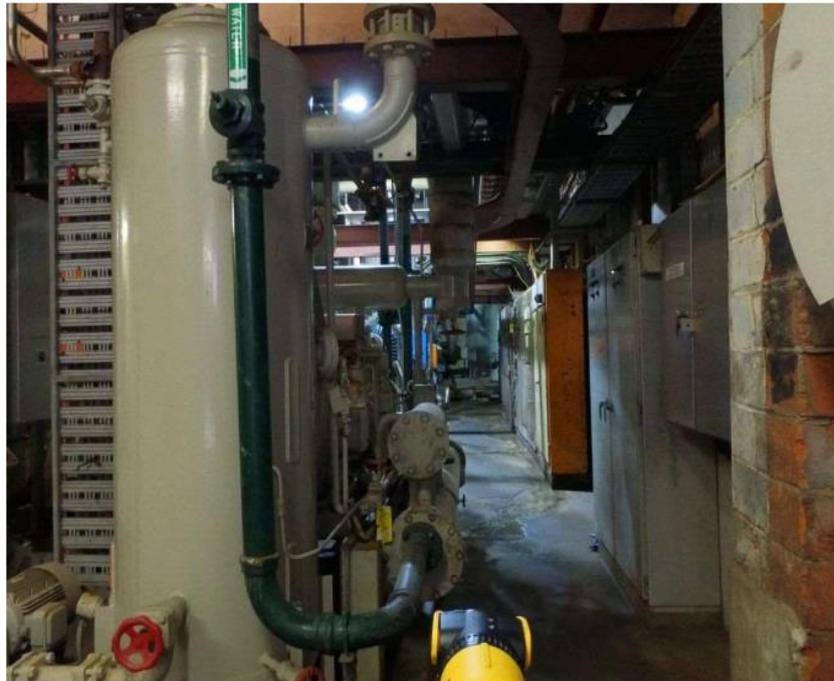
Figure 6 DroneDeploy's Photo Inspection Report

Engine Room Entry

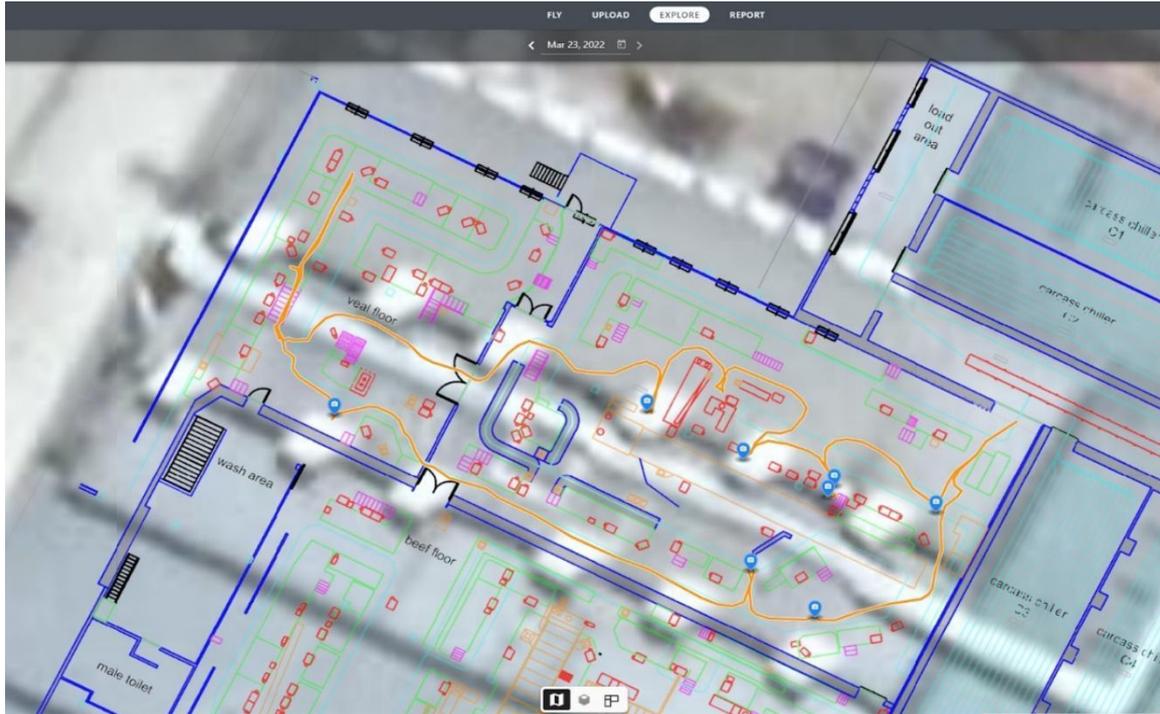
Figure 9 DroneDeploy's 360 Walkthroughs and Photos aligned to an aerial image with a Site overlay

In the images below you can see in the DroneDeploy platform the 360 walkthroughs are aligned (orange trajectory) to the facility layout drawings and the point and shoot inspection images (blue icons) are placed along the trajectory where they were taken. The user can then teleport anywhere along the orange trajectory to get a comprehensive 360 view in that location. Further movement in that view is available by clicking the augmented arrows in the image along the path.

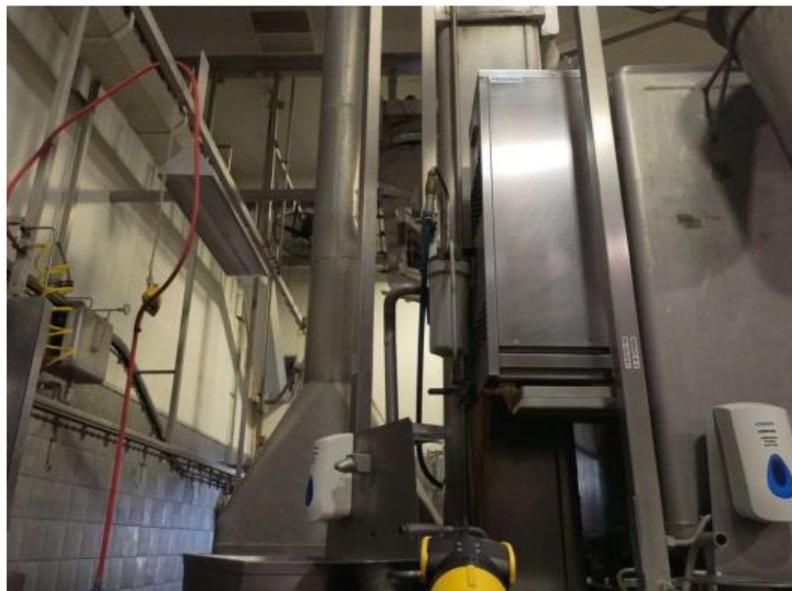
Figure 10 DroneDeploy's Photo Inspection Report

Filter Check

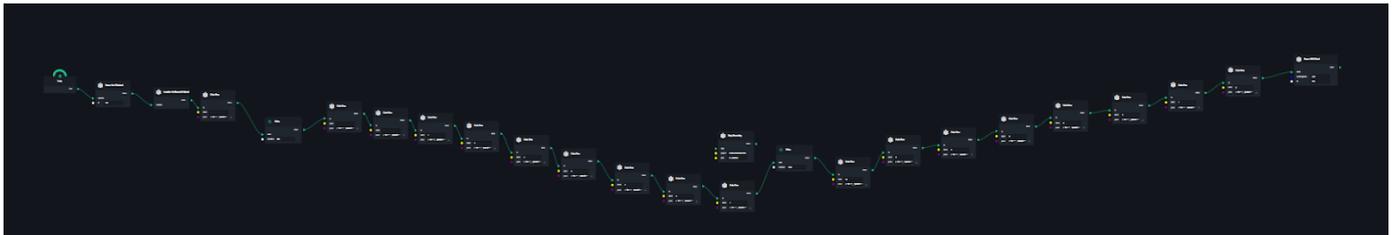
Figure 12 DroneDeploy Robotic Automate Flows

- Power On and undock the robot
- Load in the correct Map
- Navigate to the IT desk and wait for 1 minute (time to load on supplies)
- Navigate to the Tannery and wait for 2 minutes (time to offload supplies)
- Return to the IT office and Dock

The mission was executed but due to some technical issues and time constraints, this mission was never completely executed successfully.

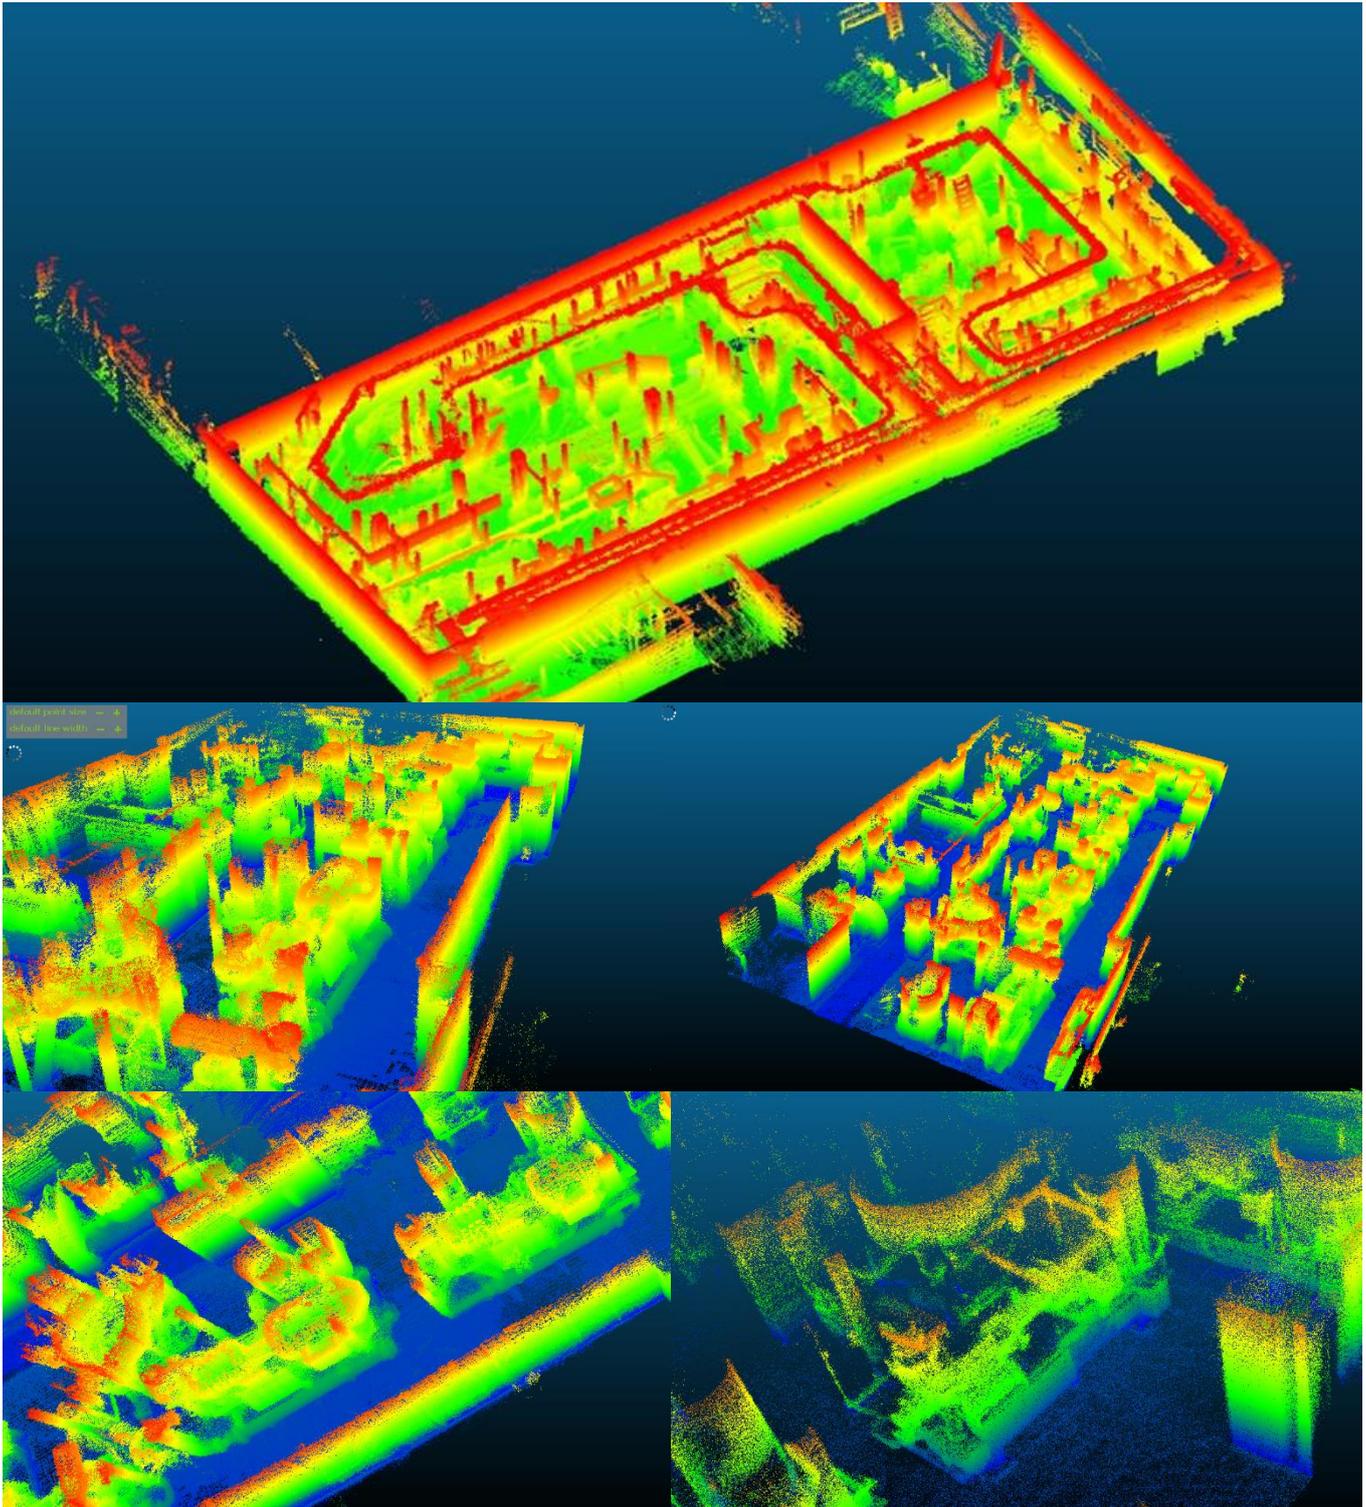
Figure 16 Point Cloud Viewing of Veal Floor and Engine Room

Using the existing LiDAR on Spot the DroneDeploy team ran a test on the solution's capability to record LiDAR for visual mapping purposes. This is a non-colourized point cloud solution which is mainly designed for navigation capabilities of the robot, not necessarily for mapping.

LiDAR relies on the return of light that is transmitted by the LiDAR unit. Having dark or highly reflective surfaces influences the return of the light which negatively affects the solution's ability to perform SLAM computations and build an accurate point cloud. As the majority of the Veal Floor is stainless steel this was the only concern.

Calibration of the Beta solution as well as fast and unpredictable movements by the robot will lead to noise and other point anomalies. As this technology is very much still a work-in-progress the quality of the results from this function are not guaranteed.
