# Suitability of Belt Materials for CO<sub>2</sub> Pellet Cleaning

**PROJECT CODE:** 2018-1052

**PREPARED BY:** The University of Adelaide and Cold Logic Pty Ltd

**DATE SUBMITTED:** 31-OCT-2018

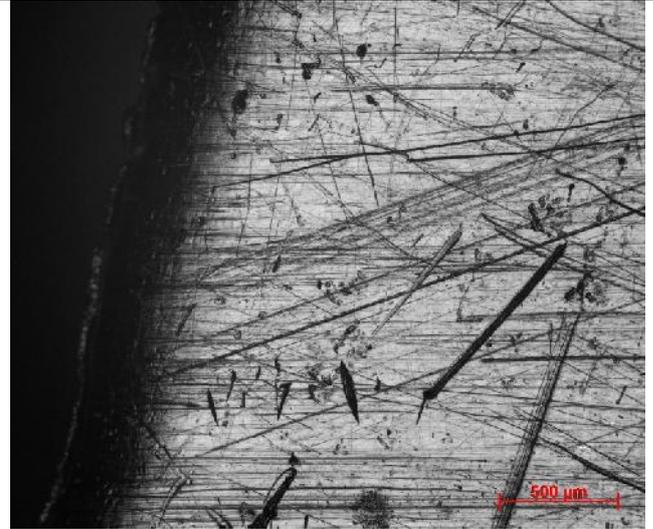
HDPE: 2 Cycles, 5× magnification

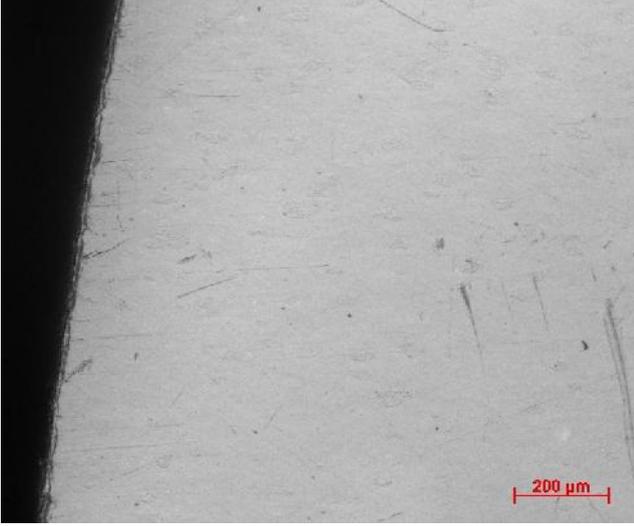
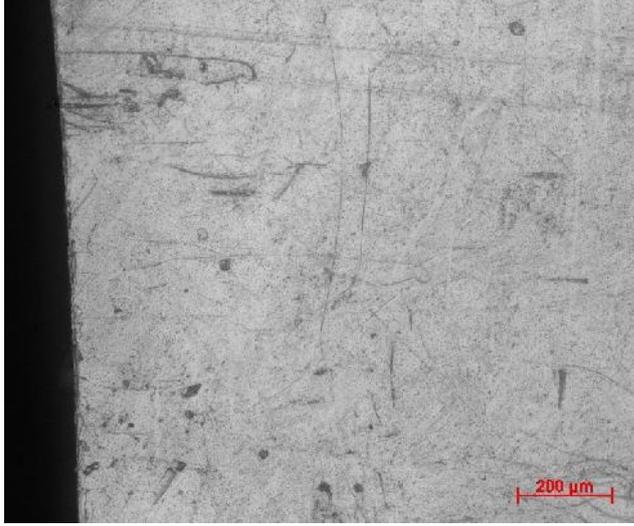
<p>Polypropylene: 1 Cycle, 10× magnification</p>	<p>Polypropylene: 2 Cycles, 10× magnification</p>

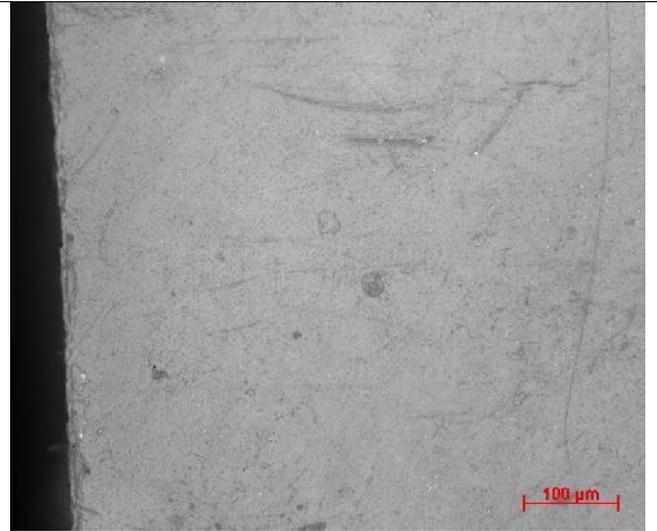
Polypropylene: 2 Cycles, 20× magnification

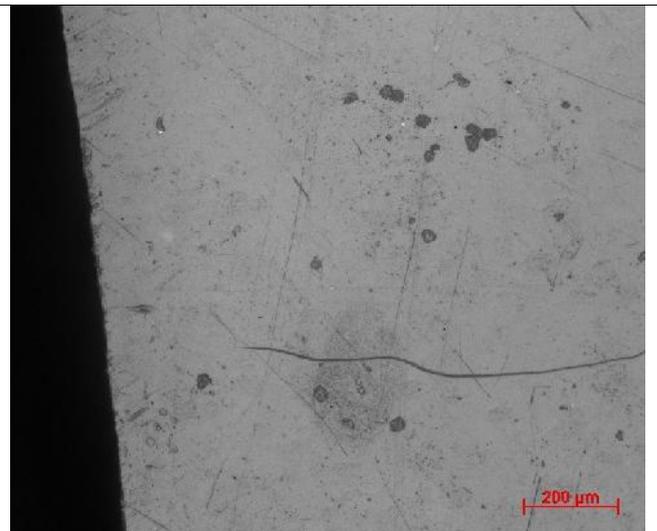
Polypropylene: 8 Cycles, 10× magnification
