Smallstock RFID

Trial of New Lamb Gambrel RFID hooks at JBS
Bordertown

Project Code
2021-1206

Published by
AMPC

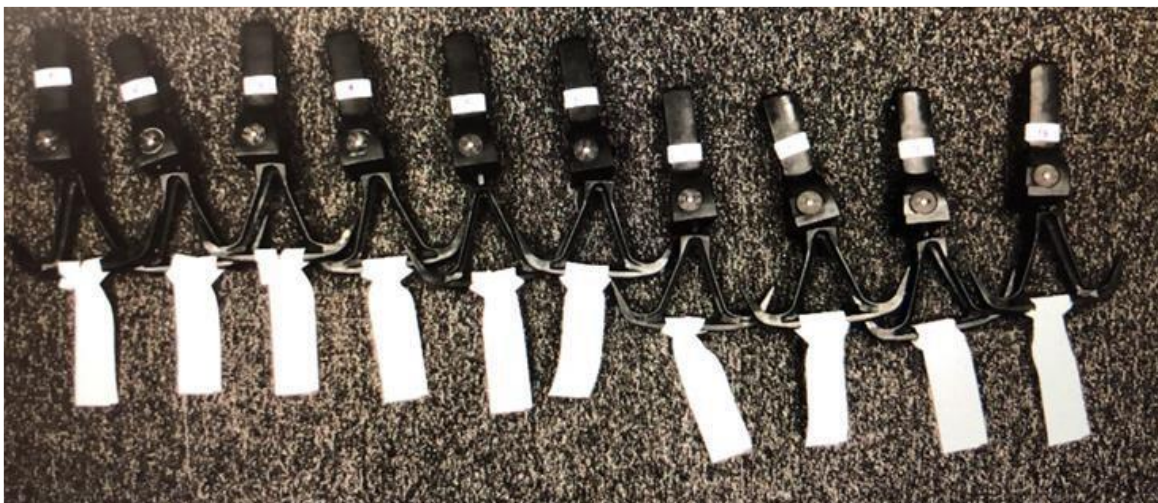
10 x hooks fitted with tags had been returned to P+F for testing. After initial test, P+F Australia found 4 x good read tags and 6 x bad read (no read) tags and sent them for further in-depth analysis to our investigation team 3 x good read tags and 5 x bad read (no read) tags.

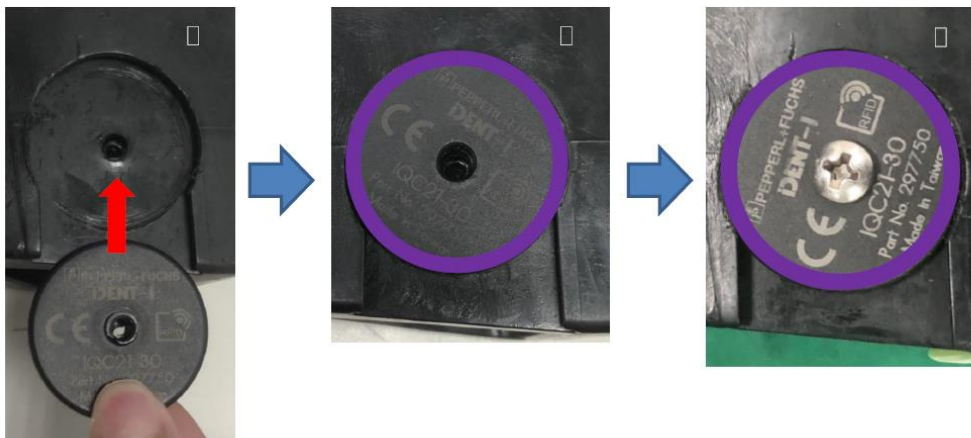
Hook and RFID Tag

Based on the hook we have received, we presumed this is how the end customer attach the RFID tags on the hook:

1. Slide the tag into the cavity from the track
2. Make sure the tag is sitting in the cavity
3. Screw the tag tightly

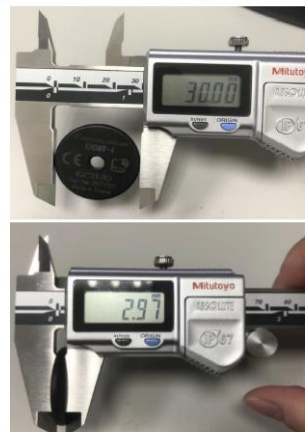
We measured the dimension of the tag to check if it was larger than size. As per below table the tag could not be fitted into the cavity of the hook as cavity size is lower than tag diameter.

No.	Diameter(mm) $30 \pm 0.2\text{mm}$	Thickness(mm) $3 \pm 0.2\text{mm}$
2	30	3.04
3	29.97	2.98
4	29.97	2.97
5	30.02	3.02
6	29.95	2.9
7	29.94	2.99
8	29.98	2.93
9	29.96	2.95

Apparently, the cavity and the track are smaller than the tag, so the tag cannot be slid into the track successfully, neither be fitted into the cavity appropriately.

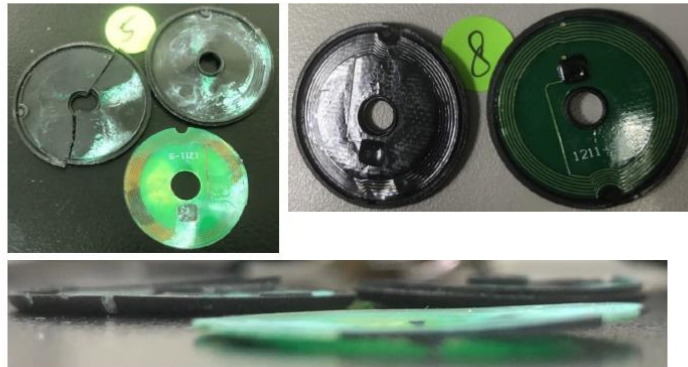
According to the tests we have done, we confirmed that the root cause of NG (No Good) tags was excessive force to press the tags down into a smaller cavity on the hook and other possible impacts. So, the tags were damaged during the assembly process and further aggravated when got impacts during the falling into the chute process. The chemical solution has permeated into the tags from the cracks. Some of the PCB have deformed and destroyed. So, the e-units were damaged and lost function gradually after repeated chemical washing cycles.
